Assessment Report

CGC HEALY

(WAGB-20)

Science Winch System Assessment

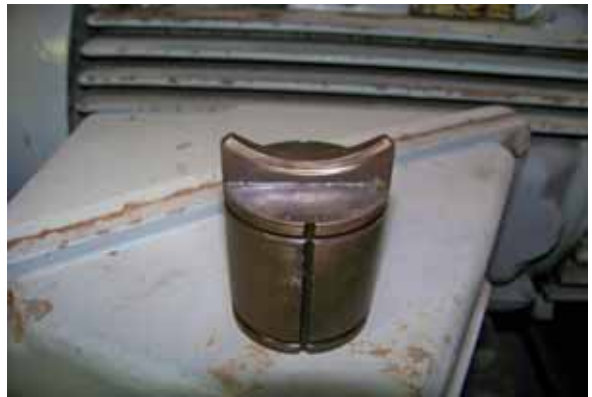
Report Number	Healy-002
Date:	4/5/2011
Vessel:	CGC Healy
Contract Number:	HSCG85-11-P-P30BX4
Equipment Affected:	O/C 1 and 2, Trawl/Core
Location:	Winch Room

Condition Found:	All the Level wind Shuttles were removed cleaned and checked for wear.
	All the shuttles were found to be in good shape.
	All were cleaned again, greased and reinstalled.
Signed:

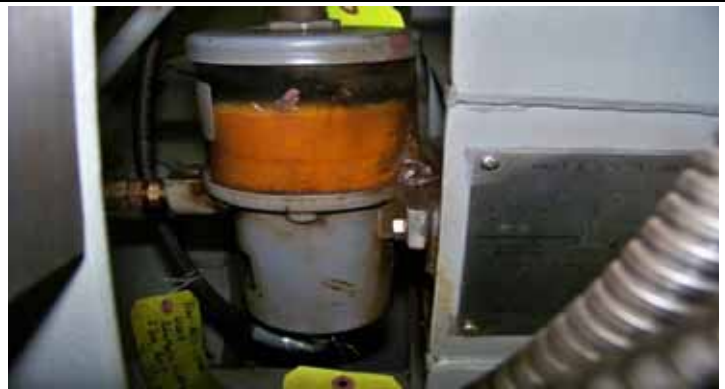
Report Number	Healy-003
Date:	4/5/2011
Vessel:	CGC Healy
Contract Number:	HSCG85-11-P-P30BX4
Equipment Affected:	Trawl/Core
Location:	Winch Room

Condition Found:	The automatic lubricator on the core winch, the bowl is full of water and sludge. It also shows signs that it may be cracked.
Recommendation:	Remove the bowl on the lubricator, disassemble the hoses and connections and clean them all of the sludge and old hard grease. If the bowl is cracked and broken it should be replaced. Trawl/Core Winch Automatic Grease Lubricator System Grease Ram Pump MFG. P/N 82886-H
Signed:

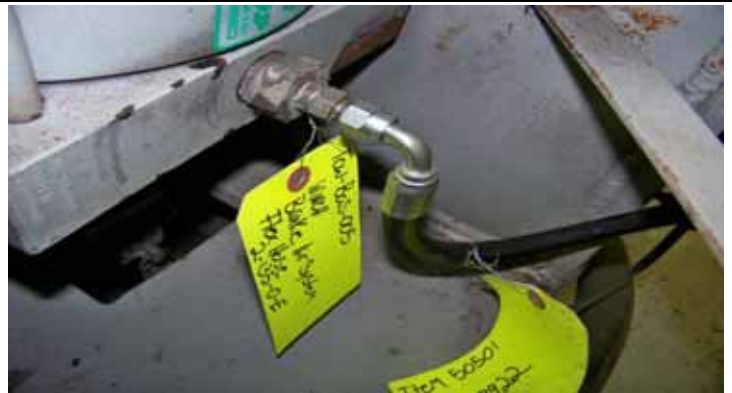
Report Number	Healy-004
Date:	4/5/2011
Vessel:	CGC Healy
Contract Number:	HSCG85-11-P-P30BX4
Equipment Affected:	Trawl/Core
Location:	Winch Room

Condition Found:	The air fitting on the air brake is broken and leaks, not allowing the brake to hold.

Recommendation:	Check all the fitting for tightness and test, if it is still leaking then replace the fittings to the brake cylinder.

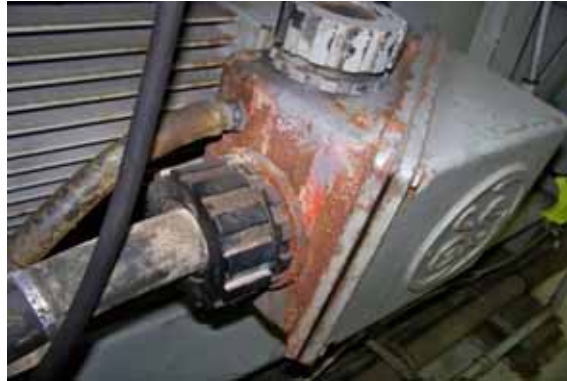
Report Number	Healy-005
Date:	4/5/2011
Vessel:	CGC Healy
Contract Number:	HSCG85-11-P-P30BX4
Equipment Affected:	Trawl/Core Winch Motor
Location:	Winch Room

Condition Found:	It was found that the electrical connection enclosure on the main motor on the Trawl/Core winch has been exposed to salt water. The box is corroded and the surface paint has peeled off.

Recommendation:	After Tag-Out and Lock-Out of the Trawl/Core winch controller and power supply. Disassemble the whole enclosure and inspect it. It may only have to be cleaned and preserved. Or replacement of the enclosure may be needed.

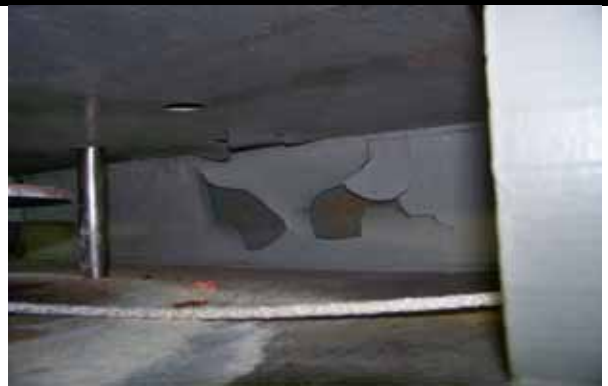
Report Number	Healy-006
Date:	4/4/2011
Vessel:	CGC Healy
Contract Number:	HSCG85-11-P-P30BX4
Equipment Affected:	O/C 420 LPR Flag block
Location:	Winch Room

Condition Found:	The flag block off of the O/C winch has a coating failure on the interior.

Recommendation:	Preservation has failed on the flag block. Power tool old coating and preserve with approved coating IAW with Coating and Color Manual (COMDTINST M10360.3 series)

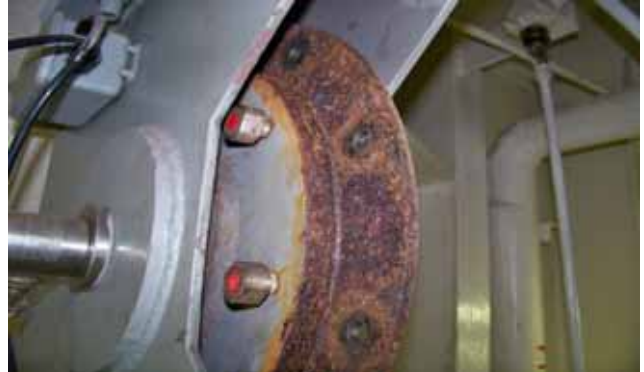
Report Number	Healy-007
Date:	4/5/2011
Vessel:	CGC Healy
Contract Number:	HSCG85-11-P-P30BX4
Equipment Affected:	Sheave Centers
Location:	Winch Room

Condition Found:	Sheave centers where the inserts are attached have excess corrosion.
Recommendation:	Remove all the inserts and wire brush or power tool clean all flaking rust. Coat all bolts and nuts with an anti seize compound to prevent the corrosion of the bolts. Also coat all unprotected surfaces.
Signed:

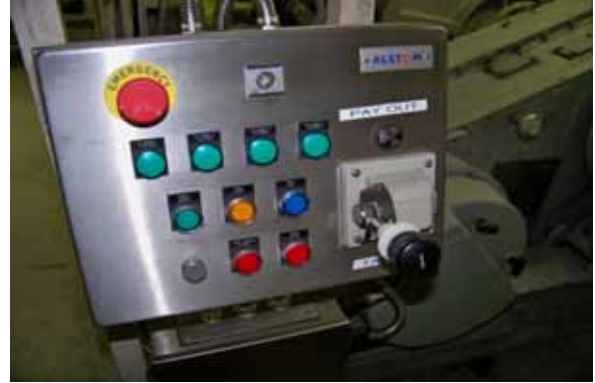
Report Number	Healy-008
Date:	
Vessel:	CGC Healy
Contract Number:	HSCG85-11-P-P30BX4
Equipment Affected:	All Controllers
Location:	Winch Room

Condition Found:	<p>Upon operational testing of the three winches, it was found that the winches could only be operated in local control. Ship's force corrected the problem and the controls were transferred and all winches operated in remote control.</p> <p style="text-align: center;">All winches operated satisfactory.</p>
Recommendation:	
Signed:

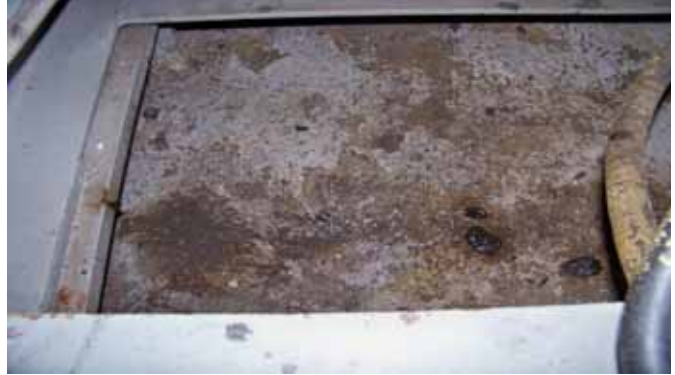
Report Number	Healy-009
Date:	
Vessel:	CGC Healy
Contract Number:	HSCG85-11-P-P30BX4
Equipment Affected:	Decks under O/C #2 and Trawl/Core Winch
Location:	Winch Room

Condition Found:	
	The deck plating is corroding and rusting under the T/C and O/C #2 winch

Recommendation:	
	Recommend power tool cleaning and preserving deck IAW COMDTINST M10360.3 (series)
